Integrated monitoring and structural analysis strategies for the study of large historical construction. Application to Mallorca cathedral

Ahmed Elyamani Ali Mohamed

Barcelona, febrero de 2015

Universitat Politècnica de Catalunya
Departament d'Enginyeria de la Construcció

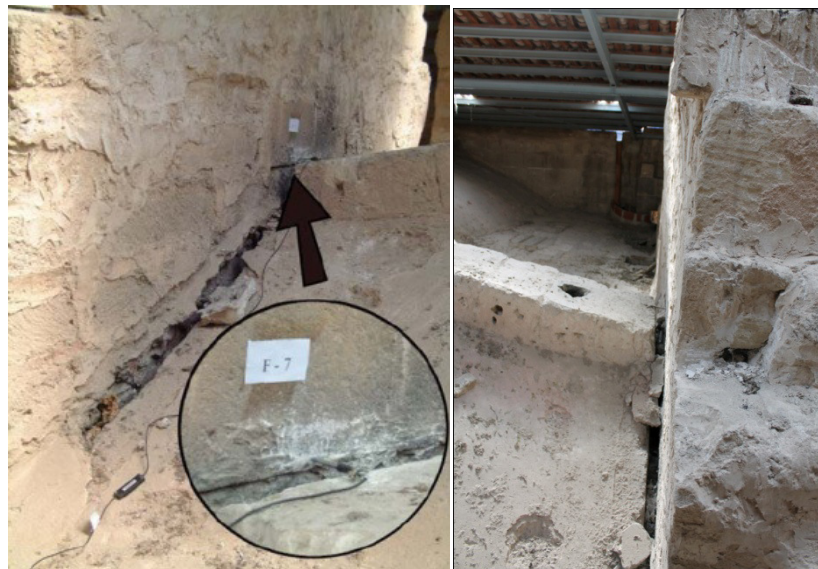
Figure 6.10. Photos for the crack between third arch and fourth vault. In the left photo a zoom is made to the static monitoring sensor.

The last updating trial was to simulate the damage experienced by the cathedral. Among the most significant damage was the cracking that can be seen in many places as previously discussed in chapter 3. One of the significant cracks is the one located between the third arch and the fourth vault from the west façade, Figure 6.10. It was previously monitored for a period of about five years and proved to be active with a rate of 1cm/century (Godde, 2009).

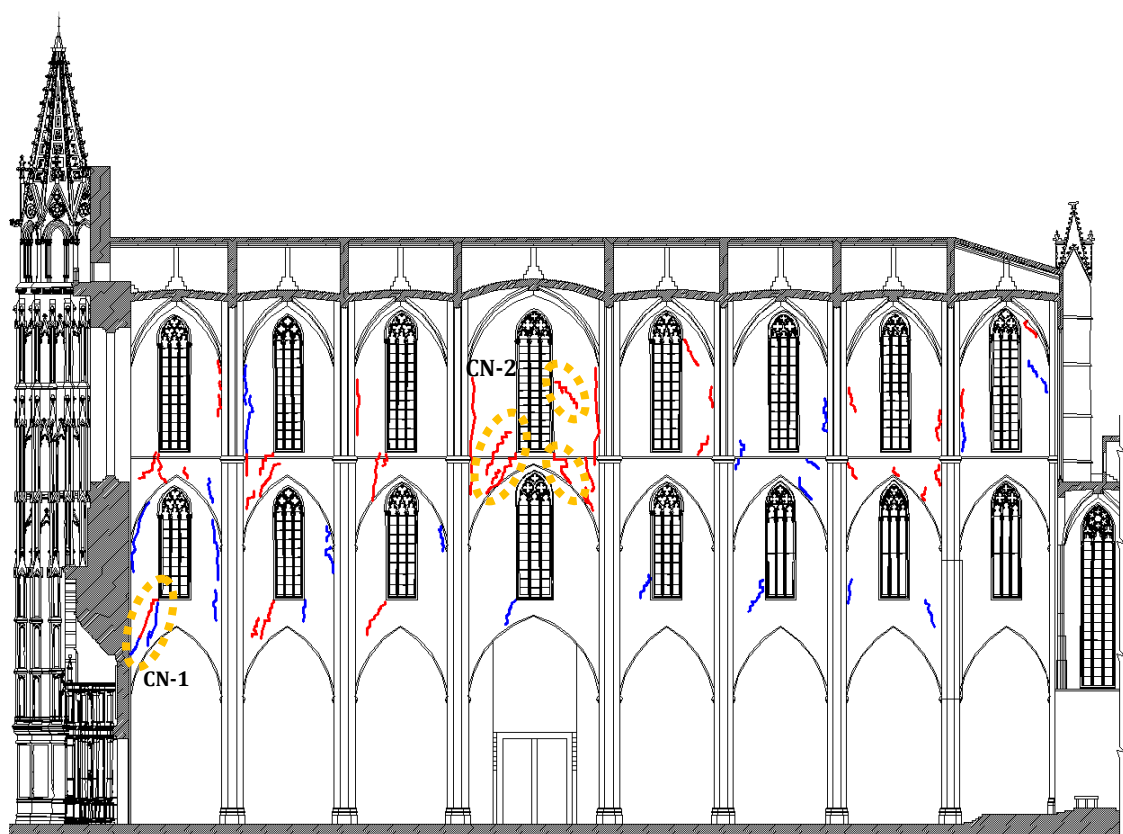
Figure 7.10. Crack survey of north (top) and south (bottom) clerestory walls. Red cracks are wider than blue ones. Photos for cracks surrounded by circles are shown in the next figure.

The damage patterns found by the numerical analysis were compared with the actual state of cracking in the cathedral to investigate if these cracks were of a seismic origin. Figure 7.10 reports the crack survey of the north and the south clerestory walls as can be seen from inside the cathedral. Some photos for some of the important cracks are shown in Figure 7.11. It was noticed that all the bays of the clerestory walls were cracked. The first four bays from the west façade showed more intensive cracking pattern when compared to the bays near the east façade. The bay with the longest span exhibited more cracks than the other bays.

Regarding the cracks shapes, two types could be noticed, the first were the diagonal cracks around the openings of the windows. The second were the vertical cracks between the walls and the supporting elements whether the columns or the buttresses. The diagonal cracks were near to those found by the pushover analysis so they perhaps related to the seismic history of the island of Mallorca.
